Report on the investigation into the
flooding and partial sinking of an
inflatable migrant boat
resulting in the loss of at least 27 lives
in the Dover Strait
on 24 November 2021

VERY SERIOUS MARINE CASUALTY

REPORT NO 7/2023

NOVEMBER 2023

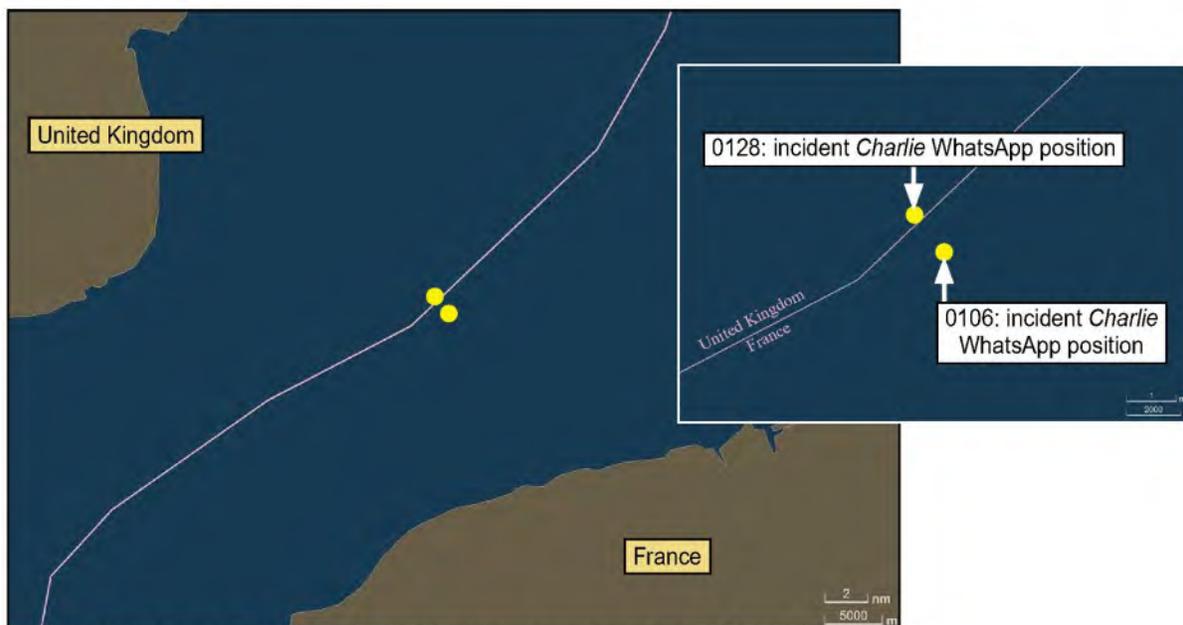
Figure 2: Reported WhatsApp positions for migrant 7/incident *Charlie* received from MRCC Gris-Nez

Inter Bank navigation buoy and the South Varne navigation buoy (**Figure 1**) and to report any sightings of small craft on VHF channel 16. At around the same time as the broadcast, MRCC Gris-Nez called MRCC Dover to report that it had received a telephone call from migrant 7 (UK incident *Charlie*) via telephone number M2 and an updated position via WhatsApp from a separate telephone number (referred to as M4 in this report) associated with the boat. The updated position was within UK waters (**Figure 2**).

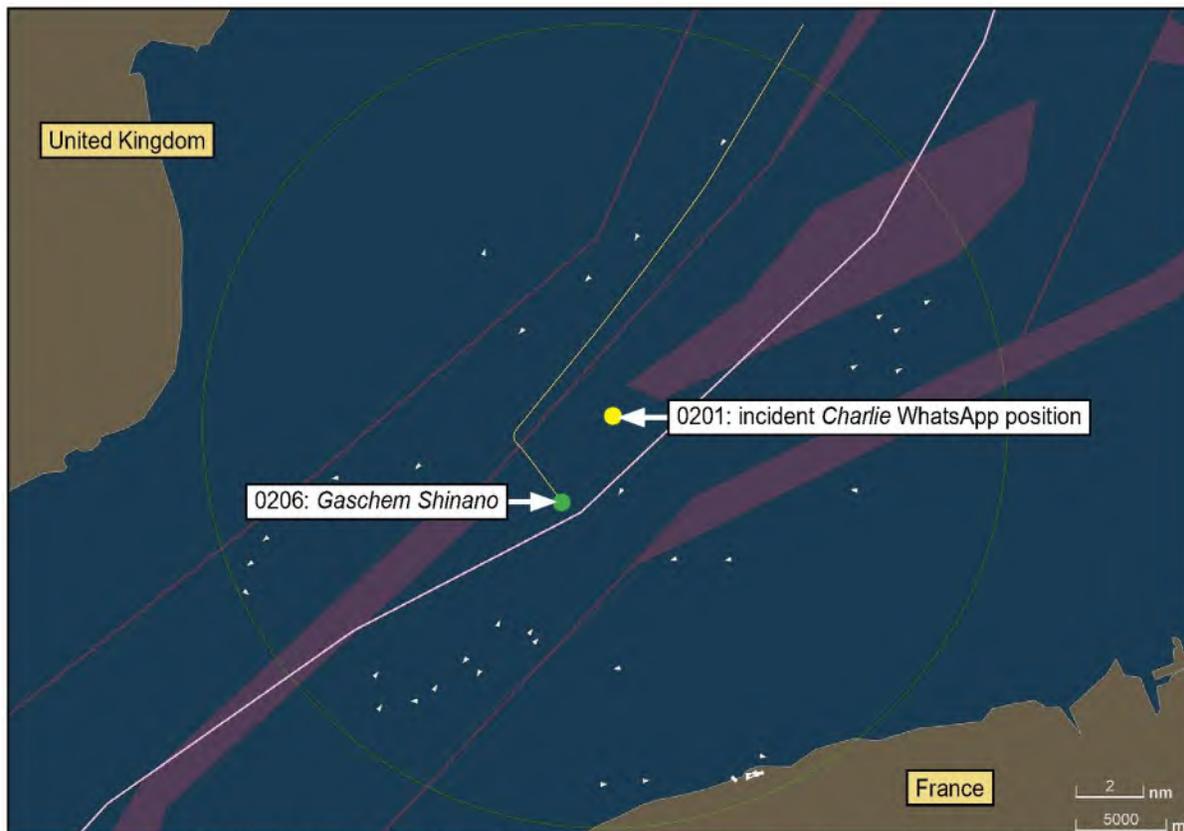
Figure 3: Location of *Gaschem Shinano* and WhatsApp position of incident *Charlie* received at 0201

At 0206, having received the incident *Charlie* WhatsApp position, MRCC Dover used VHF radio to hail the German registered LPG tanker *Gaschem Shinano* (**Figure 3**). MRCC Dover relayed that a small craft had been reported in the vicinity of *Gaschem Shinano* and asked if anything could be seen. The crew of *Gaschem*

Shinano reported no small vessels in sight. MRCC Dover requested that the vessel maintain a sharp lookout and navigate with caution. The chief engineer on board *Gaschem Shinano* went up to the bridge and an additional lookout was posted to complement the bridge watch of the captain, second officer and a lookout. The lookouts reported all lights seen and the crew adjusted both radars to try and locate the craft. All reported lights were resolved as coming from other vessel traffic in the Dover Strait or from navigational marker buoys and no small craft were detected.

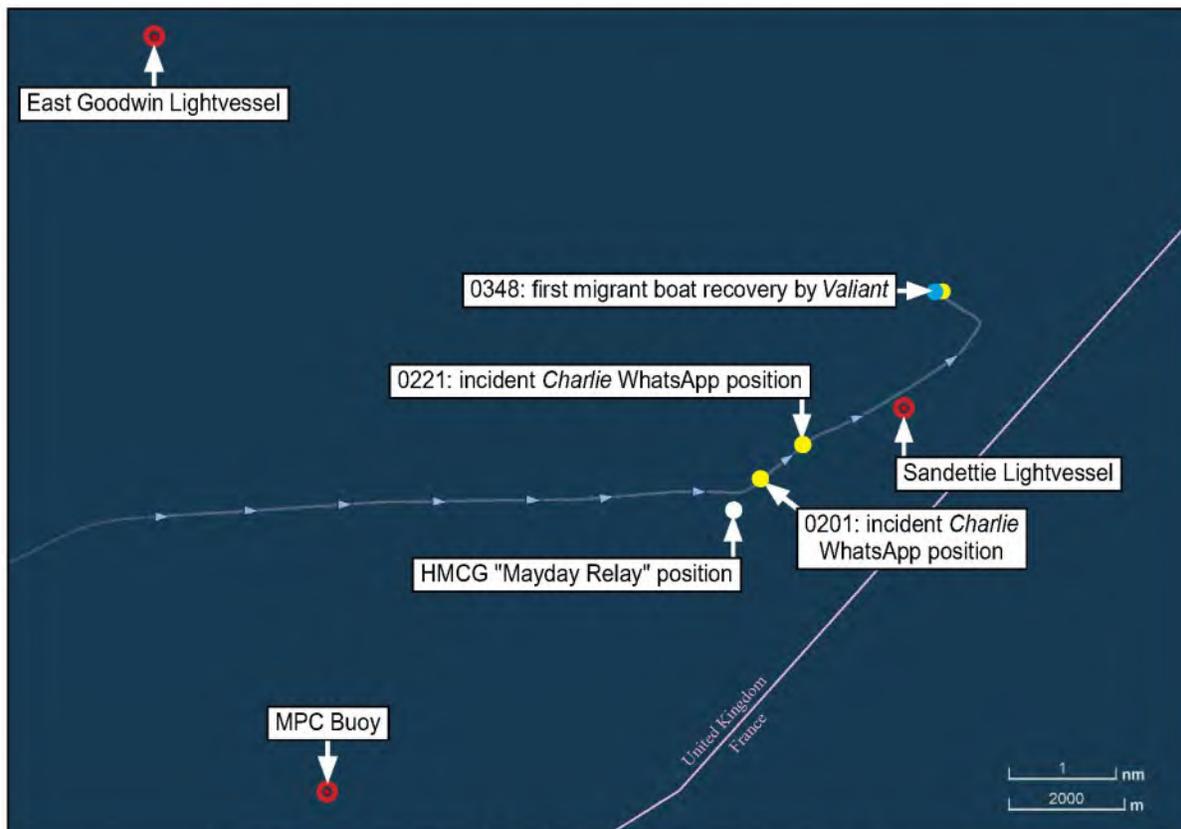
Figure 6: *Valiant's* track and position of first migrant boat recovery

Meanwhile, the crew of *Valiant* detected two migrant boats at a range of about 0.7nm using the vessel's thermal imaging camera. One of the boats was stopped in the water and the other was moving. At 0334, *Valiant* reported the sighting and its position to MRCC Dover and began heading towards the stationary boat (**Figure 6**).

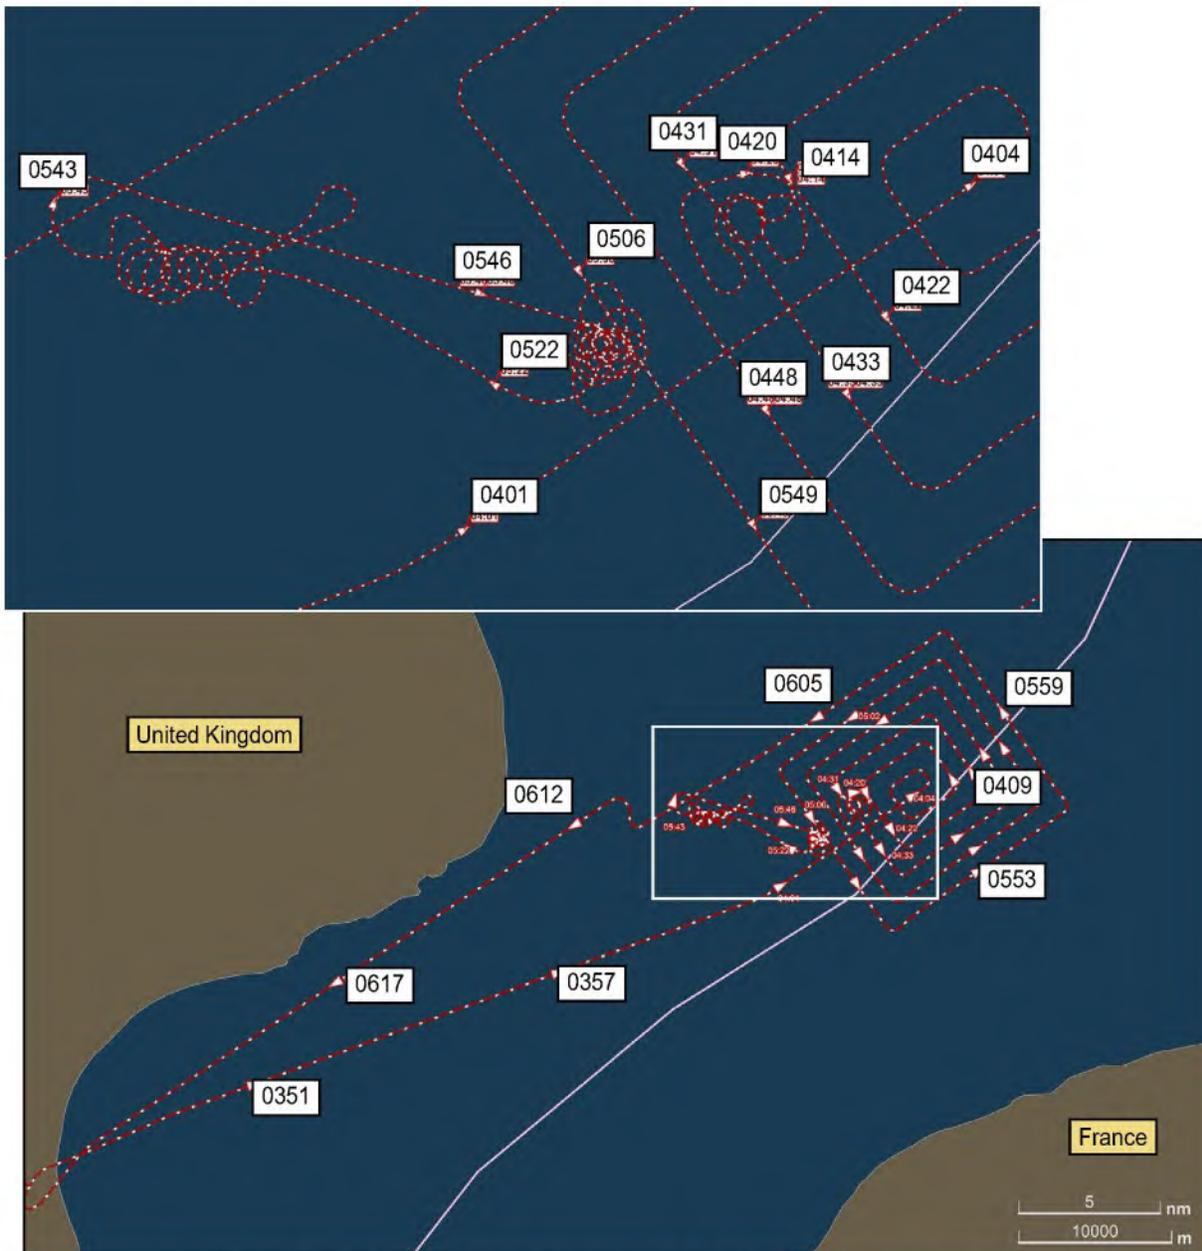
Figure 12: R163's expanding square search 24 November 2021

On 24 November 2021, R163 performed two flights. During the first flight, R163 was airborne for 2 hours and 40 minutes between 0345 and 0625 and performed an expanding square search for migrant boats with the Sandettie Lightvessel as the datum point (**Figure 12**) at an altitude of around 250ft above mean sea level and a track spacing of 0.7nm. The suggestion of the expanding square search or parallel track pattern was based upon the SMC at MRCC Dover's experience of effective search patterns for locating migrant boats, particularly those that were moving. R163 was manned by a captain and co-pilot in the front of the aircraft and a winch operator and winch paramedic in the rear. The aircraft crew searched using their NVG and the FLIR. Three migrant boats, including the boat initially located by Valiant, were detected and their positions were passed to Valiant via MRCC Dover. On completion of the expanding square search, and nearing the end of its fuel endurance, R163 was stood down by the SMC and returned to Lydd.

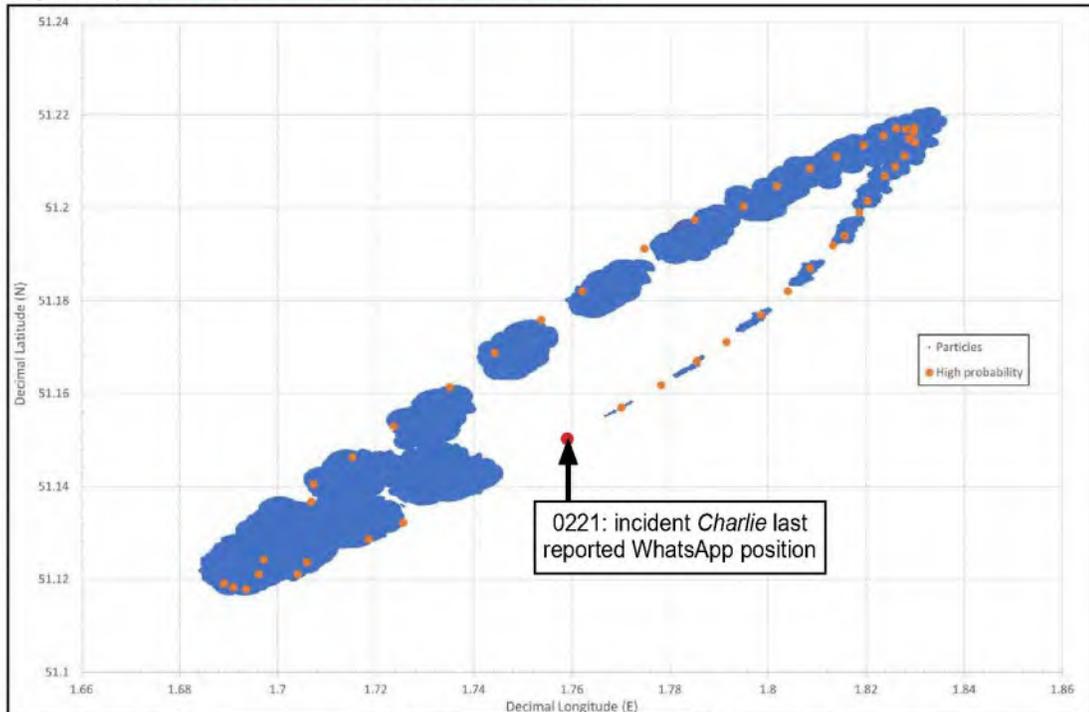
Figure 21: Image showing CEFAS modelled projected drift pattern from last reported WhatsApp position

To understand what scenario would result in the modelling reaching the found position, a series of variations were modelled assuming a southerly movement of the inflatable boat for 1 hour, at varying speed, from the time and location of the last reported position. This further analysis showed that a southerly movement at 2.5kts for 1 hour would reconcile the modelled drift track with the found position.

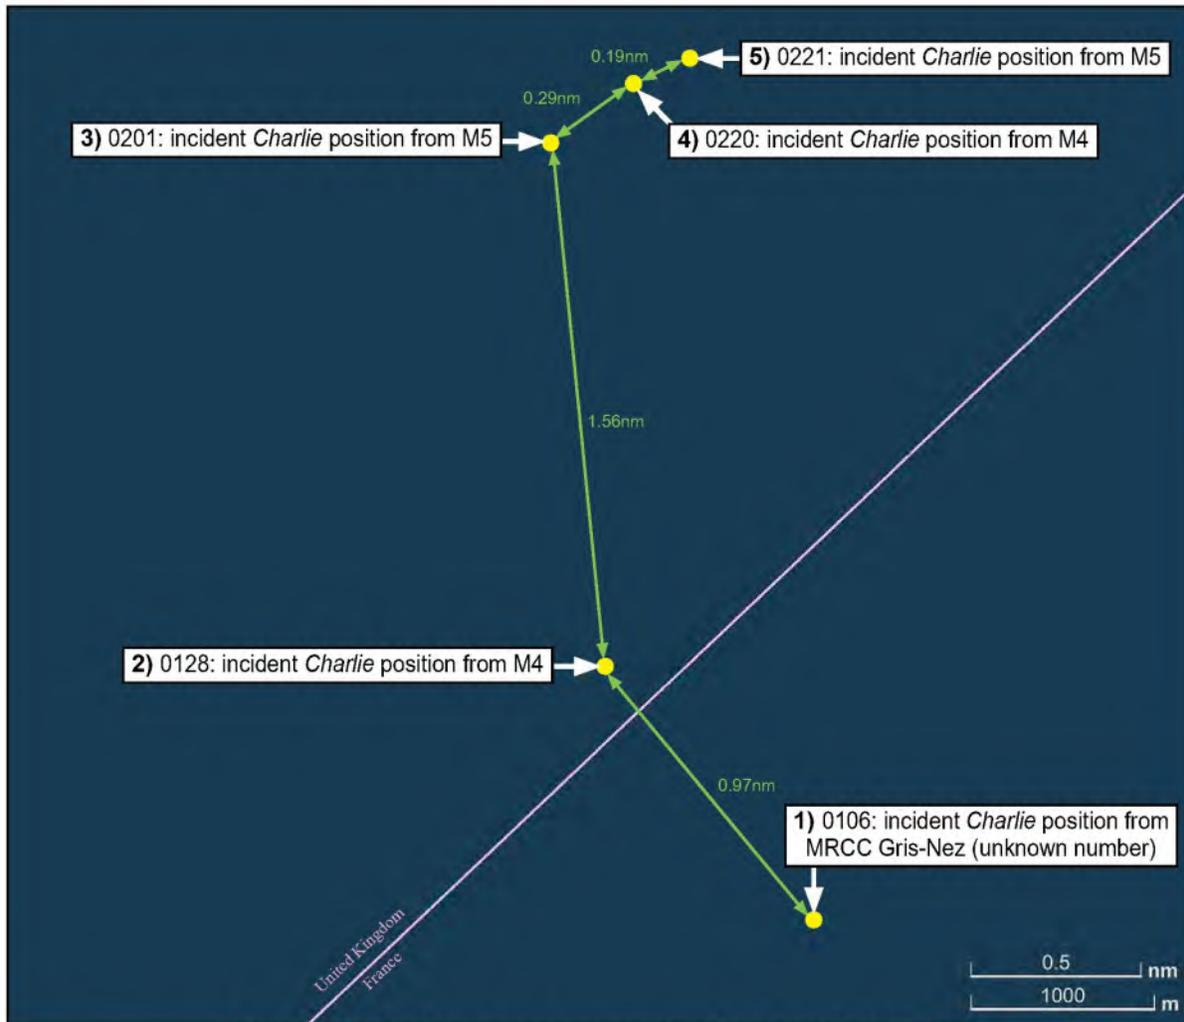
Figure 24: WhatsApp positions received from incident *Charlie*

Over the course of incident *Charlie* HM Coastguard received five WhatsApp positions from the boat's occupants. Two of these were in French waters and were passed via MRCC Gris-Nez while the remaining three were in UK waters. The positions received along with the time of receipt and approximate distances between positions are shown in **(Figure 24)**. Positions 2 and 4 were received from the same telephone number (M4) as were positions 3 and 5 (M5); it is unknown what telephone number position 1 was received from.

The approximate distance between positions 1 and 2 was 0.97nm and there was a time difference of 18 minutes, equating to an approximate speed of 3.2kts. The approximate distance between positions 2 and 3 was 1.55nm and there was a time difference of 33 minutes between them, equating to a required speed of 3.4kts. Both of these speeds would be reasonable for a laden migrant boat under engine power.

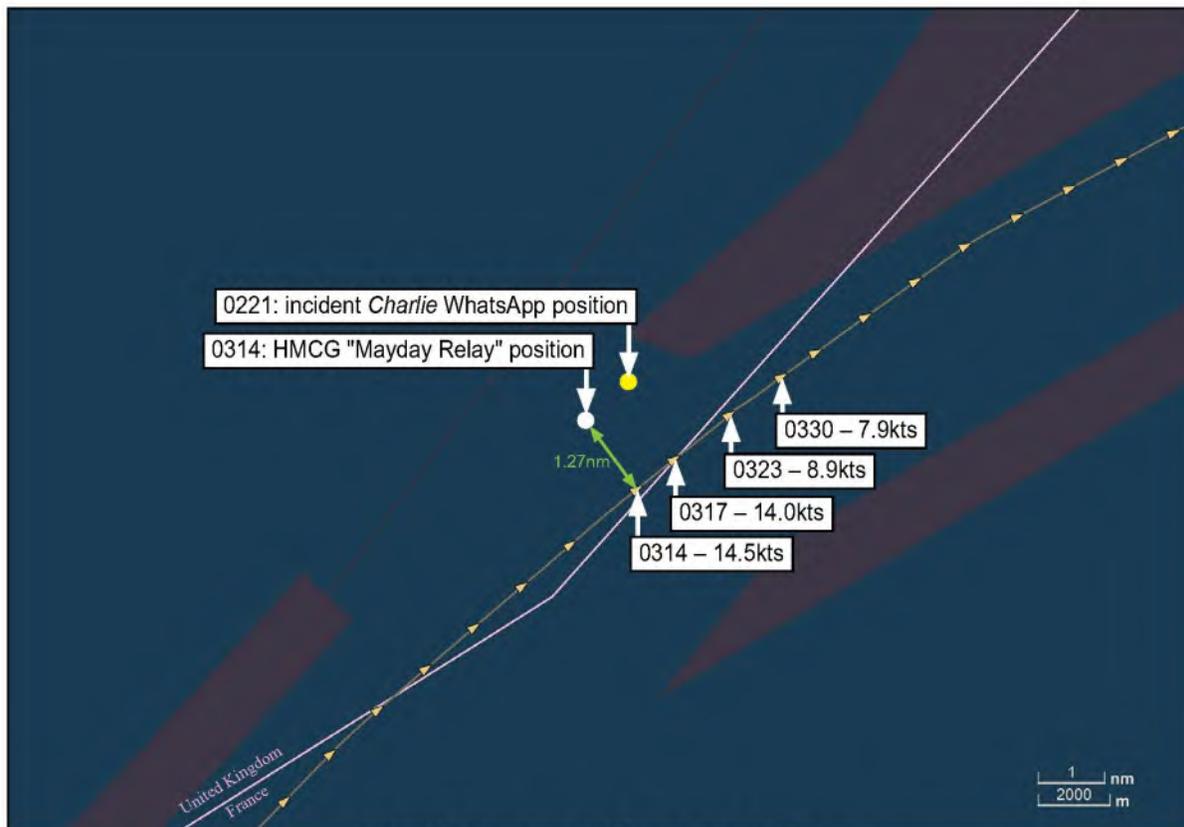
Figure 25: Analysis of *Concerto's* AIS track

Concerto’s logged position at 0323 was 2.2nm from the “Mayday Relay” position and approximately 1.6nm east-south-east of migrant boat *Charlie*’s last reported WhatsApp position. Analysis of AIS data (**Figure 25**) showed that *Concerto*’s closest point of approach to the “Mayday Relay” position occurred at 0314, when the vessel was 1.27nm to the south-south-east. At 0317, *Concerto* began to slow down from 14.5kts, reducing its speed to 7.9kts by 0330, after which the vessel’s speed began to increase again. This indicated that *Concerto*’s crew likely sighted a migrant boat shortly before 0317. *Concerto*’s position at this time was approximately 1.5nm from the “Mayday Relay” position and 1.3nm from migrant boat *Charlie*’s last reported WhatsApp position at 0221. *Concerto*’s crew did not record that the migrant boat it sighted was in distress or displaying any recognised distress signals, only that it was unlit. This investigation’s analysis (see section 2.3.2) has concluded that, by this time, migrant boat *Charlie* was likely to have been in a severely distressed state and may have been swamped, with people in the water. Consequently, it is unlikely that migrant boat *Charlie* was the boat seen by *Concerto* and the crew had likely seen one of the other small migrant boats in the area. That said, without knowing the exact location of the boat sighting, its distance from *Concerto*, and with migrant boat *Charlie*’s position uncertain, the possibility that the boat seen by *Concerto* was incident *Charlie* cannot be completely discounted.
