Report on the investigation into the
flooding and partial sinking of an
inflatable migrant boat
resulting in the loss of at least 27 lives
in the Dover Strait
on 24 November 2021

VERY SERIOUS MARINE CASUALTY

REPORT NO 7/2023

NOVEMBER 2023

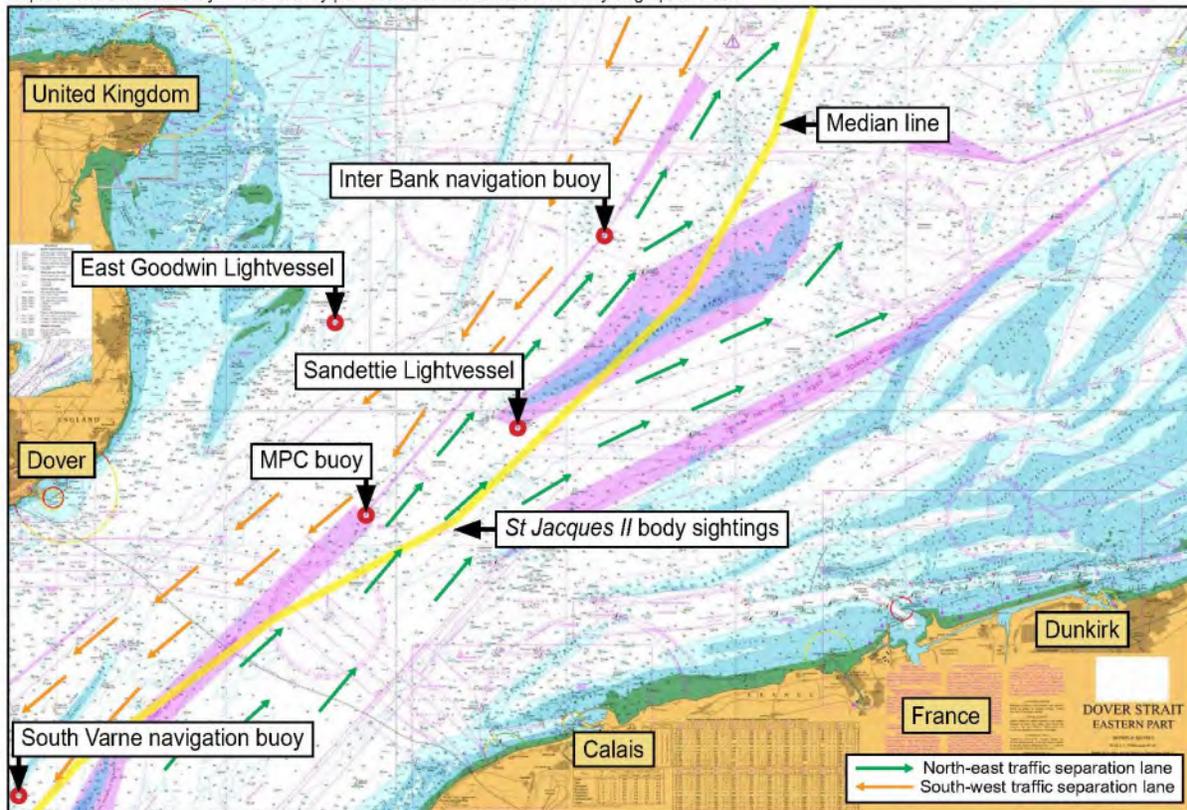
Figure 1: Chart extract of the Dover Strait, showing median line and traffic separation scheme and the reported location of *St Jacques II* initial body sightings

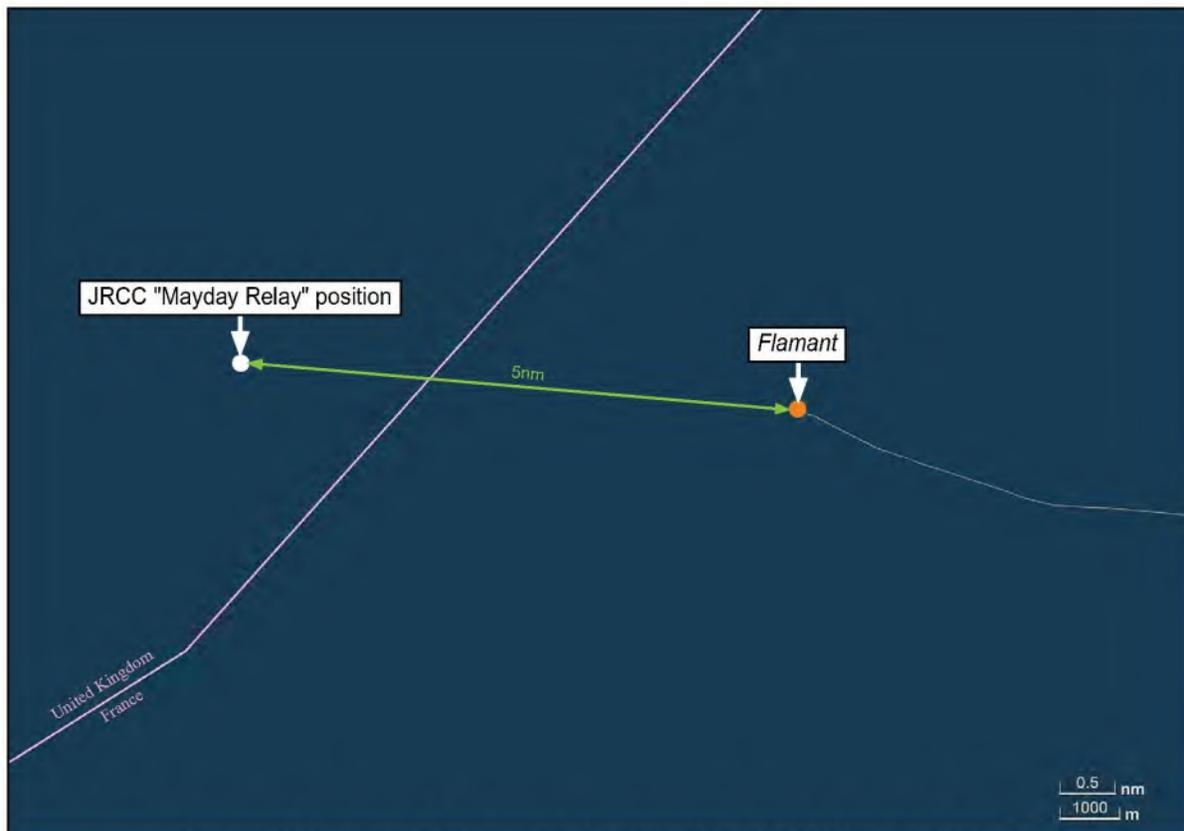
The JRCC broadcast the "Mayday Relay" on behalf of MRCC Dover at 0227 and repeated it at 0247, 0301 and 0320. At the time of the first "Mayday Relay" broadcast the SMC at MRCC Dover identified via the automatic information system (AIS) that the closest government vessel to the mayday position was the French navy patrol vessel *Flamant* (Figure 4).

Figure 4: Position of *Flamant* at the time of the 0227 "Mayday Relay"

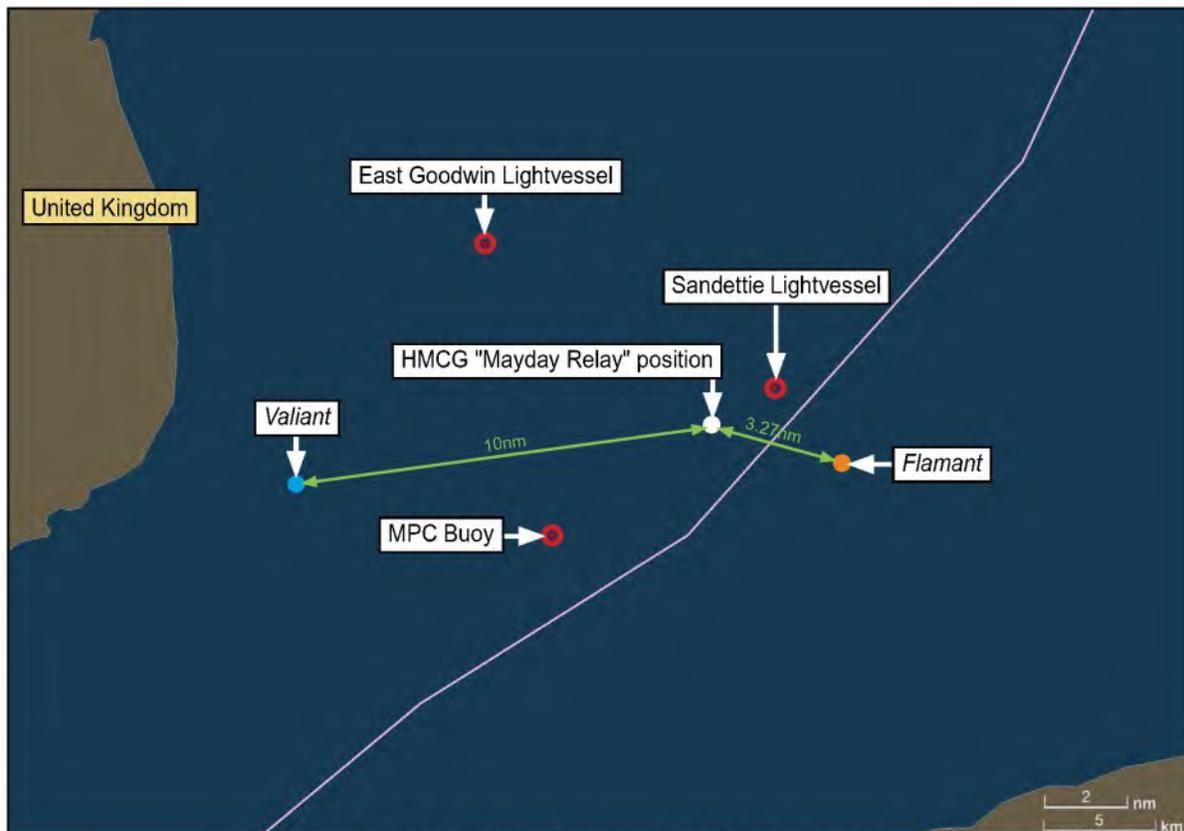
Figure 5: Positions of *Flamant* and *Valiant* at 0242

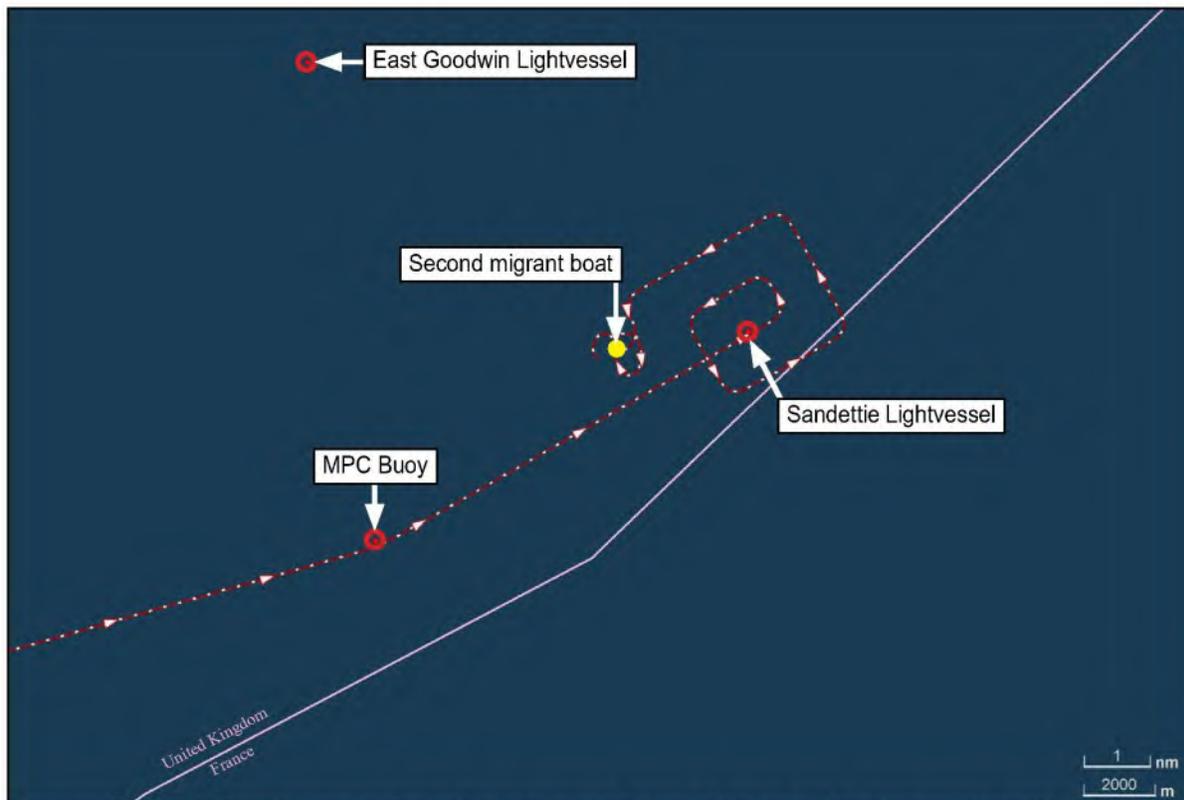
Figure 7: Initial reported position of second migrant boat and R163 search to 0418

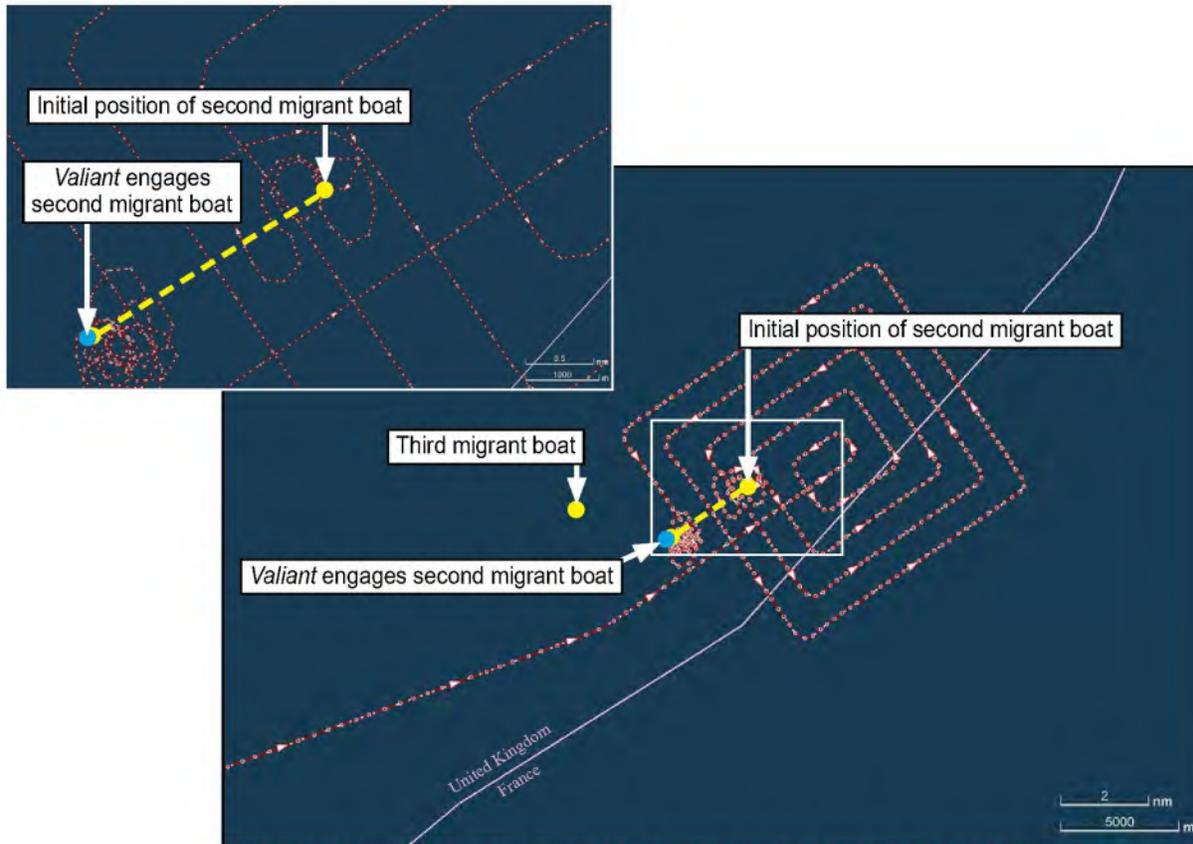
Figure 8: Initial reported position of third migrant boat and R163 search to 0519

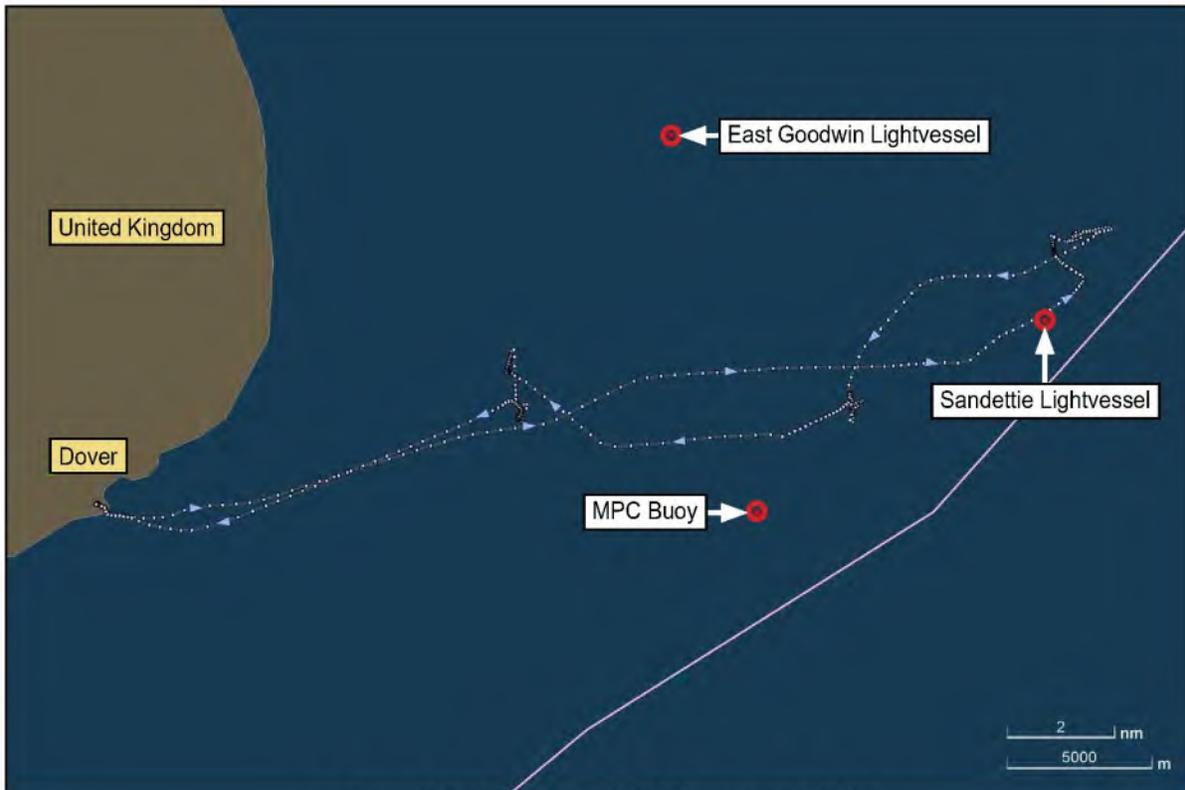
Following a discussion with HM Coastguard at 0120, at about 0130 on 24 November 2021, Border Force MCC tasked *Valiant* to deploy to the position of a suspected migrant boat inside UK waters. At 0200, *Valiant* departed from Dover and proceeded towards the position of incident *Charlie* that had been reported at 0128 via WhatsApp; *Valiant's* target was updated to the "Mayday Relay" position while underway. On board were 11 crew and a member of the immigration enforcement Criminal and Financial Investigation team. At about 0324, *Valiant* arrived at the "Mayday Relay" position and, finding nothing, started searching towards the Sandettie Lightvessel. *Valiant's* crew were using the cutter's mast-mounted mid-wavelength infrared thermal imaging camera when, at about 0335, they identified two suspected migrant boats, one moving and one stopped. *Valiant* proceeded towards the stopped migrant boat and deployed its RHIB to investigate. *Valiant* subsequently embarked 35 migrants from the stopped boat before proceeding towards the position of a second migrant boat, which had been reported by *R163*. At about 0519, *Valiant* made contact with the second boat and embarked 31 migrants. *Valiant* was then tasked to a third boat and, at about 0630, embarked a further 32 migrants. With 98 migrants on board *Valiant* had reached maximum capacity and so returned to Dover, where it berthed at about 0816 and, by 1030, had completed the disembarkation of the migrants (**Figure 10**).

Figure 10: Valiant's track 24 November 2021

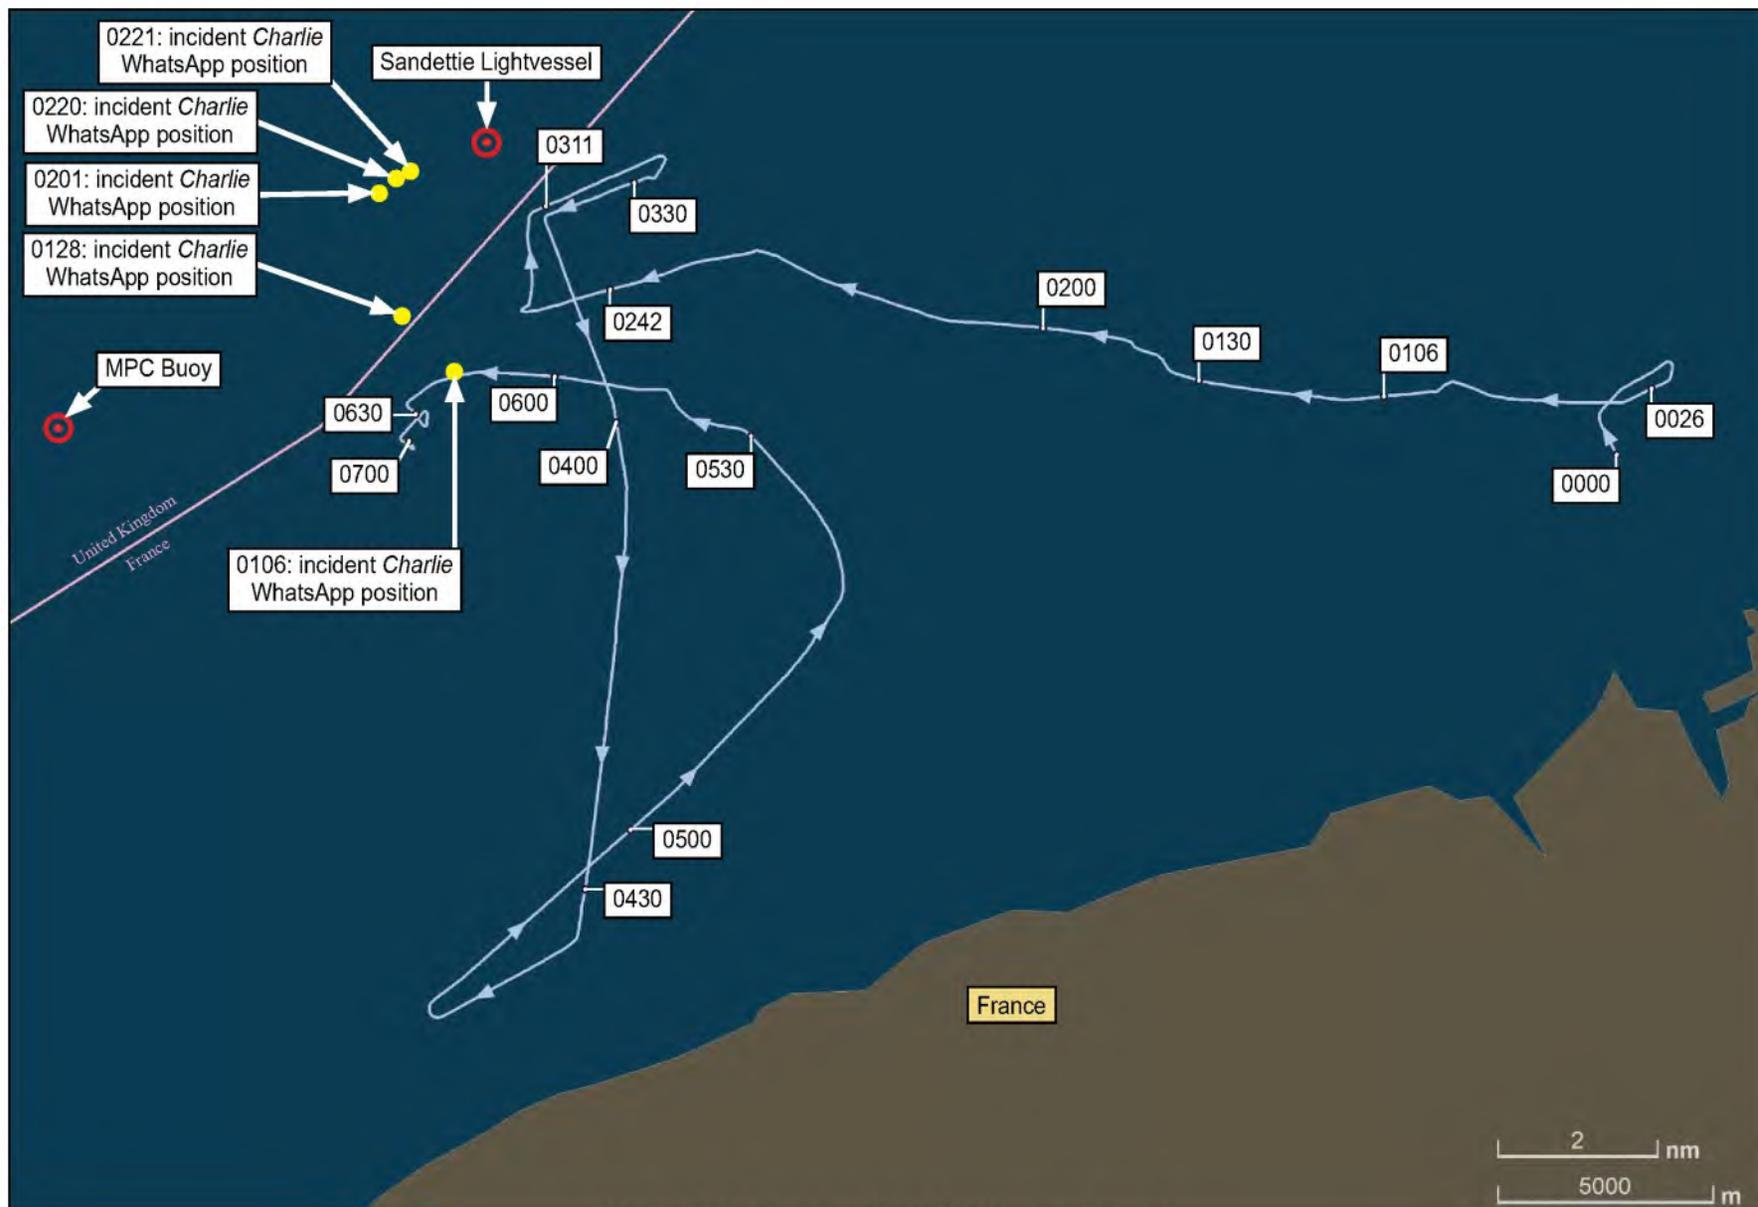
The MAIB's investigation was not provided with details of *Flamant*'s tasking or operation on 23/24 November 2021. An overview of the vessel's movements was reconstructed through examination of AIS tracks and has been presented to add context to the narrative (**Figure 13**).

Figure 13: *Flamant's* track 24 November 2021

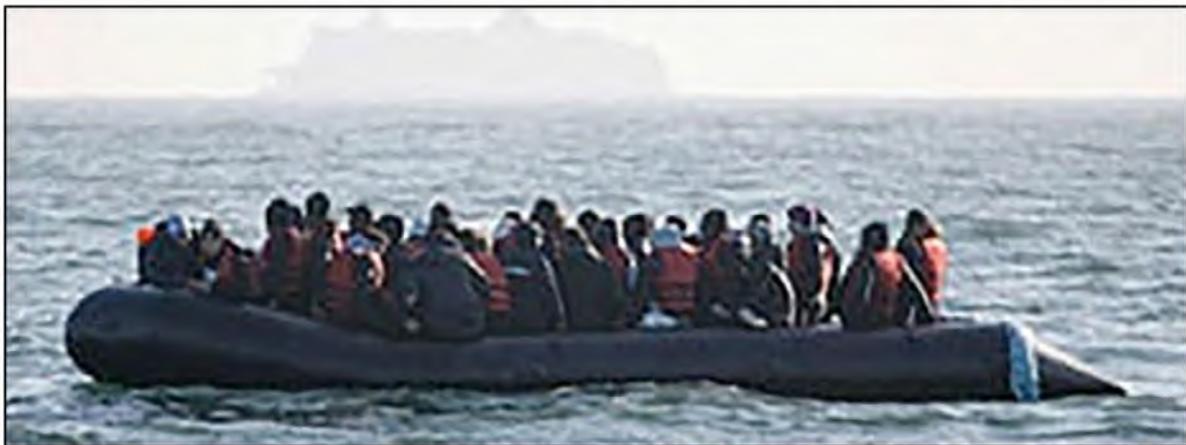
The majority of crossings were attempted in inflatable boats, ranging from small inflatables intended for use as tenders (**Figure 16**) to larger boats of up to 10m that were capable of carrying greater numbers of migrants; routinely 40 to 50, occasionally up to 80 or more. It was reported that recovered boats often showed signs of poor construction and substandard materials and that many showed no sign of having been constructed by a recognised manufacturer. The migrant boats generally carried no safety equipment and there was no evidence of VHF radios, personal locator beacons or Emergency Position Indicating Radio Beacons; equally, the boats were neither registered nor fitted with radar reflectors, navigation lights, flares or AIS transponders. The wearing of a personal flotation device (PFD) was reported to be patchy, with some migrants recovered wearing solid foam lifejackets or buoyancy aids while others either had no flotation devices at all or were equipped with inflatable rubber rings designed as swimming pool toys (**Figure 17**).

Figure 16: A typical migrant boat

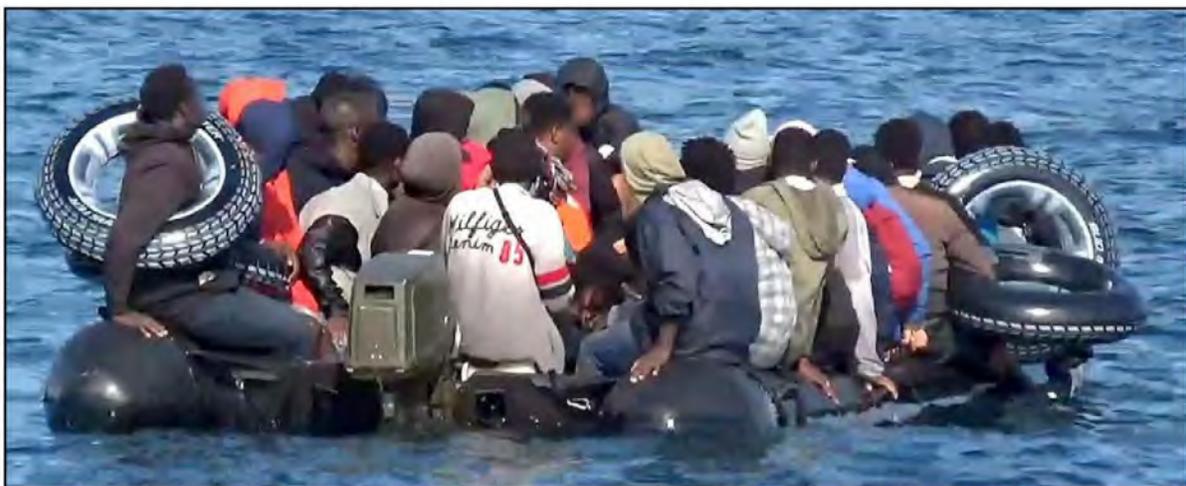
Figure 17: A migrant crossing, showing swimming pool toys used as flotation devices

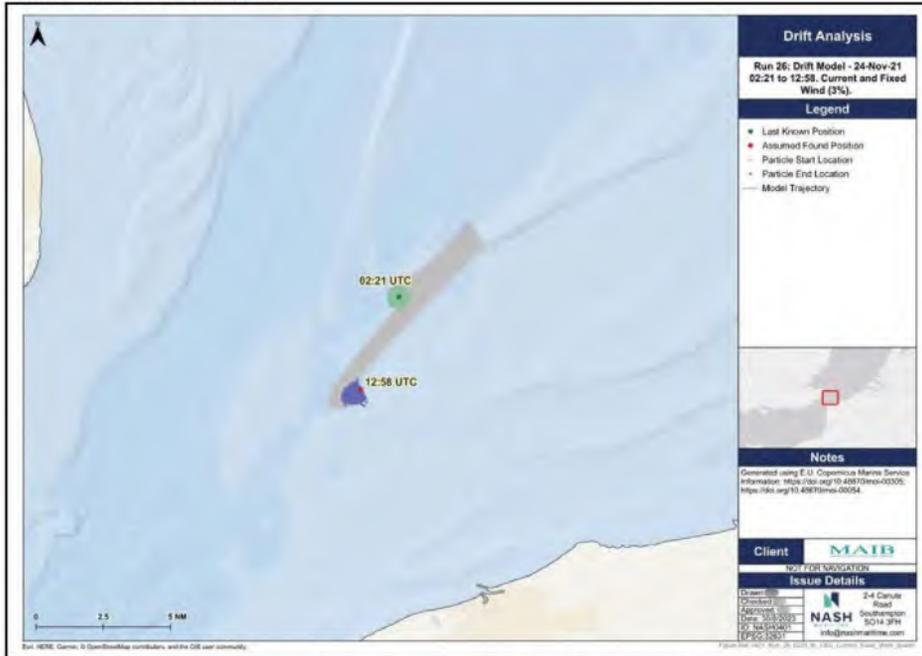
Using different variables NASH reported a wide possible range of outcomes but concluded that the model results indicated it was possible that the wind and tidal currents could largely explain the drift of objects from the last reported to the found position. The closest match between the incident's last reported position and assumed found position was achieved with a 3% wind drift applied to the fixed average measured wind data and modelled time/space varying surface flow data. Using this data both the forward and backward tracks resulted in a projected start or end position at or within 50m of the last reported or found position (**Figures 22a and 22b**).

Figure 22a: Image showing the closest match NASH modelled projected drift pattern from last reported WhatsApp position

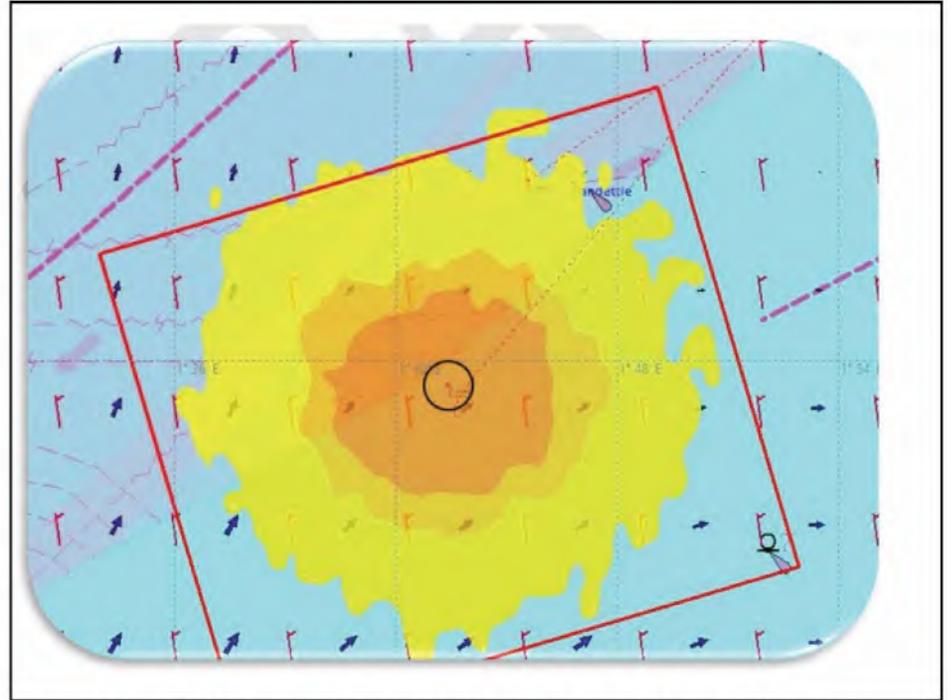
Figure 23b: Image showing high, medium and low end location probability bands around the found position using the BMT actual wind model for a person in the water

Modelled trajectories showed similar flattened anticlockwise ellipses oriented on a north-easterly axis. The closest modelled path was achieved using the liferaft object with the Copernicus tidal data and the observed wind resulted in a distance of 0.57km between the end position and the found position and the found position was within the 'high' band of probability predicted by the modelling (**Figure 23a**). The same tidal and wind inputs with a person in the water resulted in a 1.7km distance between the end position and the found position. The closest modelled path with a person in the water was achieved using POL CS3 tidal data and wind-driven current based on observed wind. This resulted in a distance of 1km between the end position and the found position and the found position was within the 'high' band of probability predicted by the modelling (**Figure 23b**).
